NASA Contractor Report 187092

Advanced Development Receiver Thermal Vacuum Tests With Cold Wall

Final Report

Leigh M. Sedgwick
*The Boeing
Company
Seattle, WA*

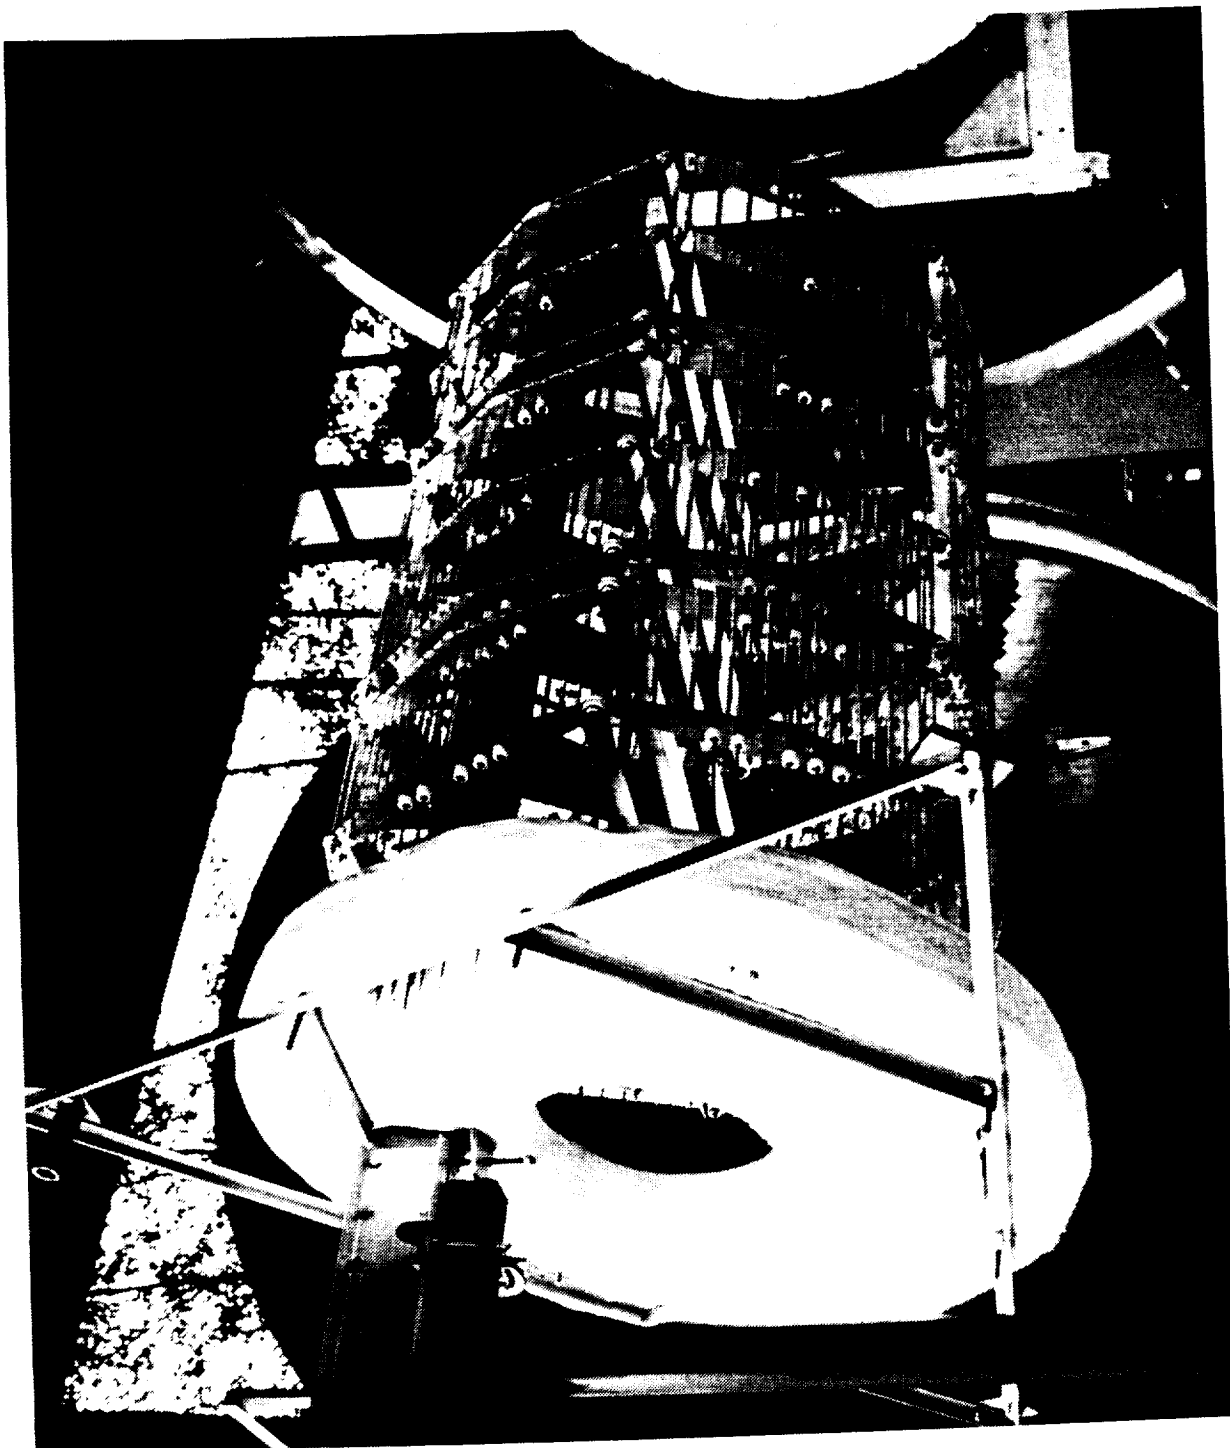
Figure 4-18: Completed Quartz Lamp Array Prior To Installation Into the Receiver Cavity.

The cantilever stand shown in Figure 4-13 was used to support the quartz lamp heater structure during the assembly process. Figure 4-13 shows the front aperture assembly supported by the lamp array box beam prior to the installation of the six circumferential quartz lamp zones. The top lamp zone (Zone A) was assembled onto the box beam first as shown in Figure 4-14. Simple wood supports were used at each end of the heater to secure the aluminum rails that provided temporary support of the lamp zones. The wood supports were disassembled after the lamp zones were secured to each other by their ceramic insulated attachments. Figures 4-15 through 4-17 illustrate the assembly process at various stages in the operation. The zones were assembled in the following order: zone A, zones B and F, zones C and E, and zone D (zone A is the top zone and the zone letters increment clockwise around the circumference as viewed from the front, aperture end of the array). All parts were white-gloved handled during this assembly operation. Figure 4-17 shows the lamp array after all of the lamp zones were in place but prior to installing the ceramic insulators attaching zone D to zones C and E. After these were in place, the wood support structure was disassembled leaving the completed lamp array supported by the cantilever stand as shown in Figure 4-18.

Prior to installing the lamp array into the receiver cavity, a check was made of all 30 heater zones to ensure no shorts existed and that all quartz lamps were operational. A large variac was used to supply just enough voltage to each of the heater zones to dimly illuminate the lamps (about 30 volts). The lamps were all wiped down with alcohol just prior to the illumination tests. No shorts were detected but about 7 lamps had cracked quartz envelopes and burned out upon power up (elements oxidized and broke). The burned out lamps showed no particular pattern in the lamp array. After replacement of all of the burned out lamps, a 2nd low power checkout confirmed that all quartz lamps were operational.

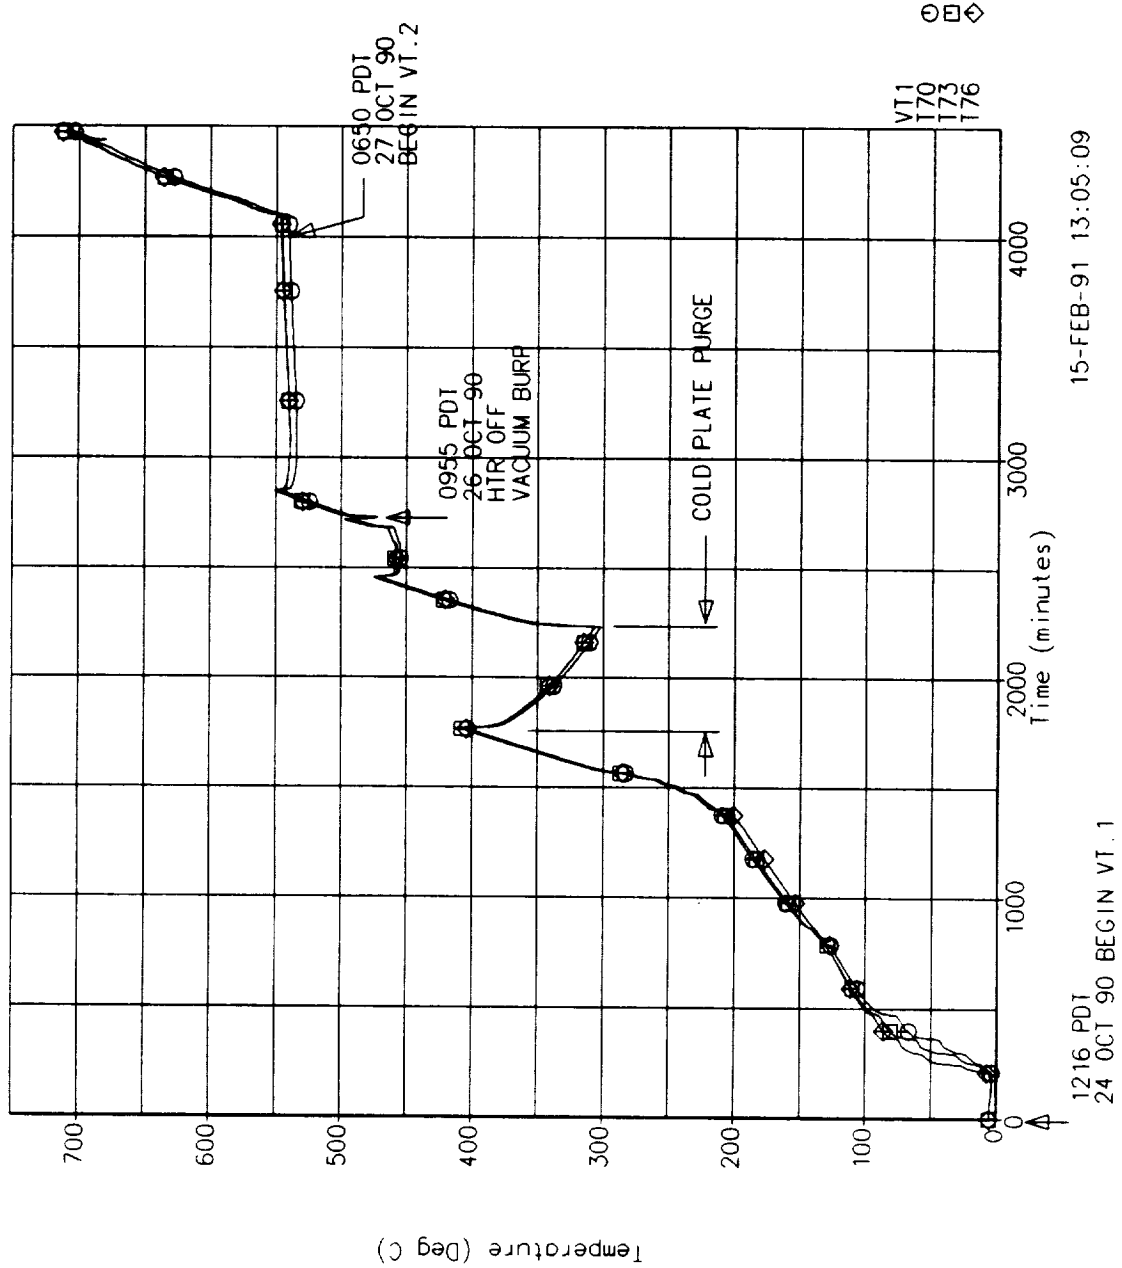
Figure 5-1: Cavity Side-Wall Surface Temperatures at the Front (Aperture End), Middle, and Back of the Receiver Cavity During VT.1.

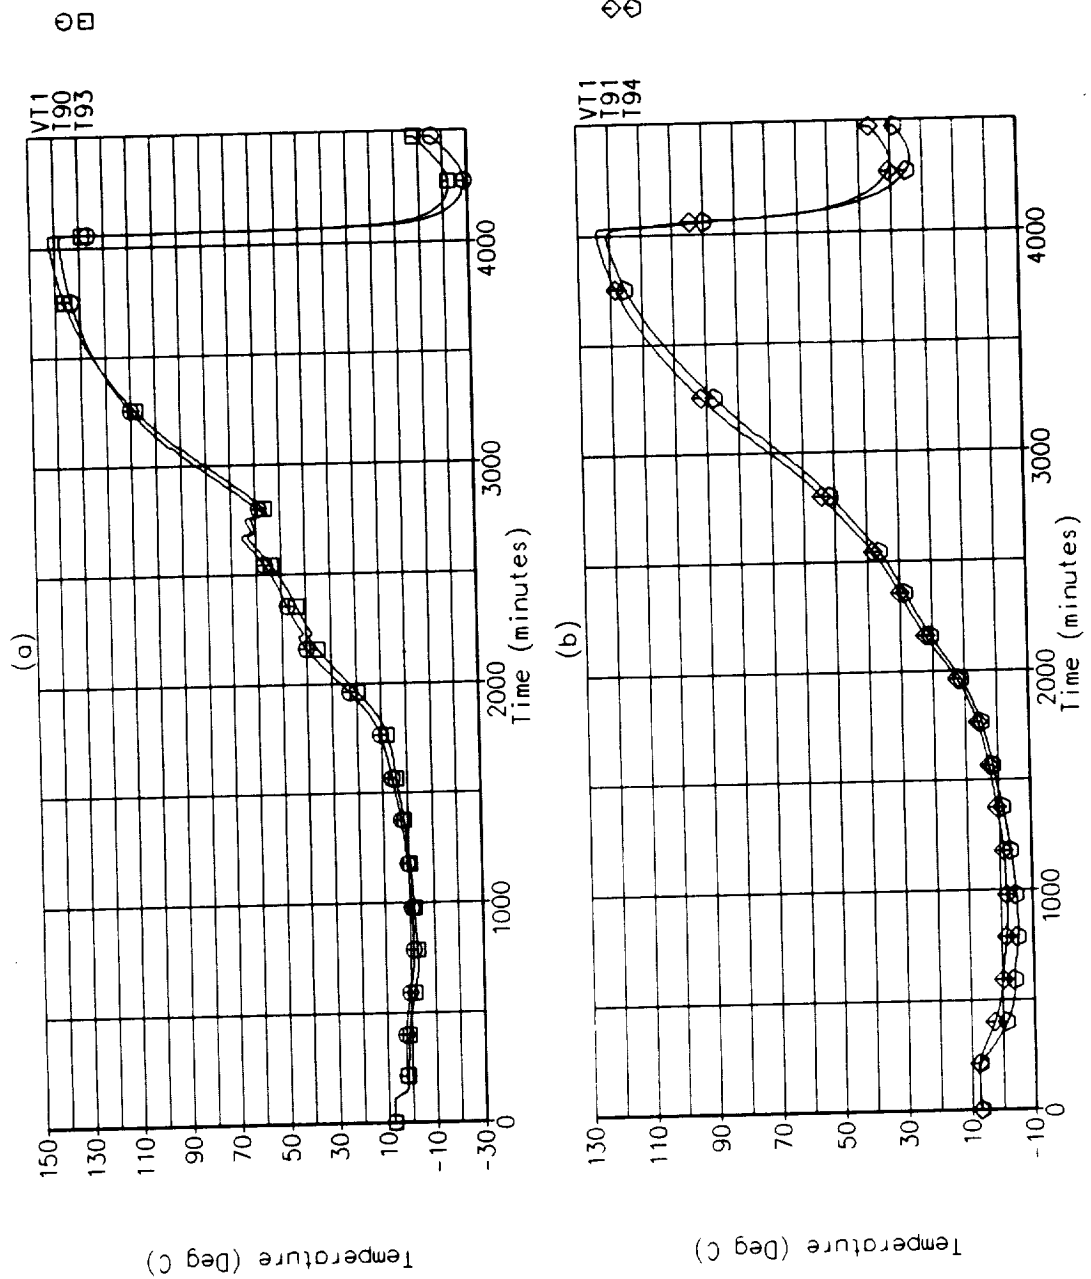
Figure 5-3: (a) Exterior Side-Wall Surface Temperatures Parallel to Heat Storage Tube #4 During VT.1; and (b) Exterior Side-Wall Surface Temperatures Parallel to Heat Storage Tube #12 During VT.1.

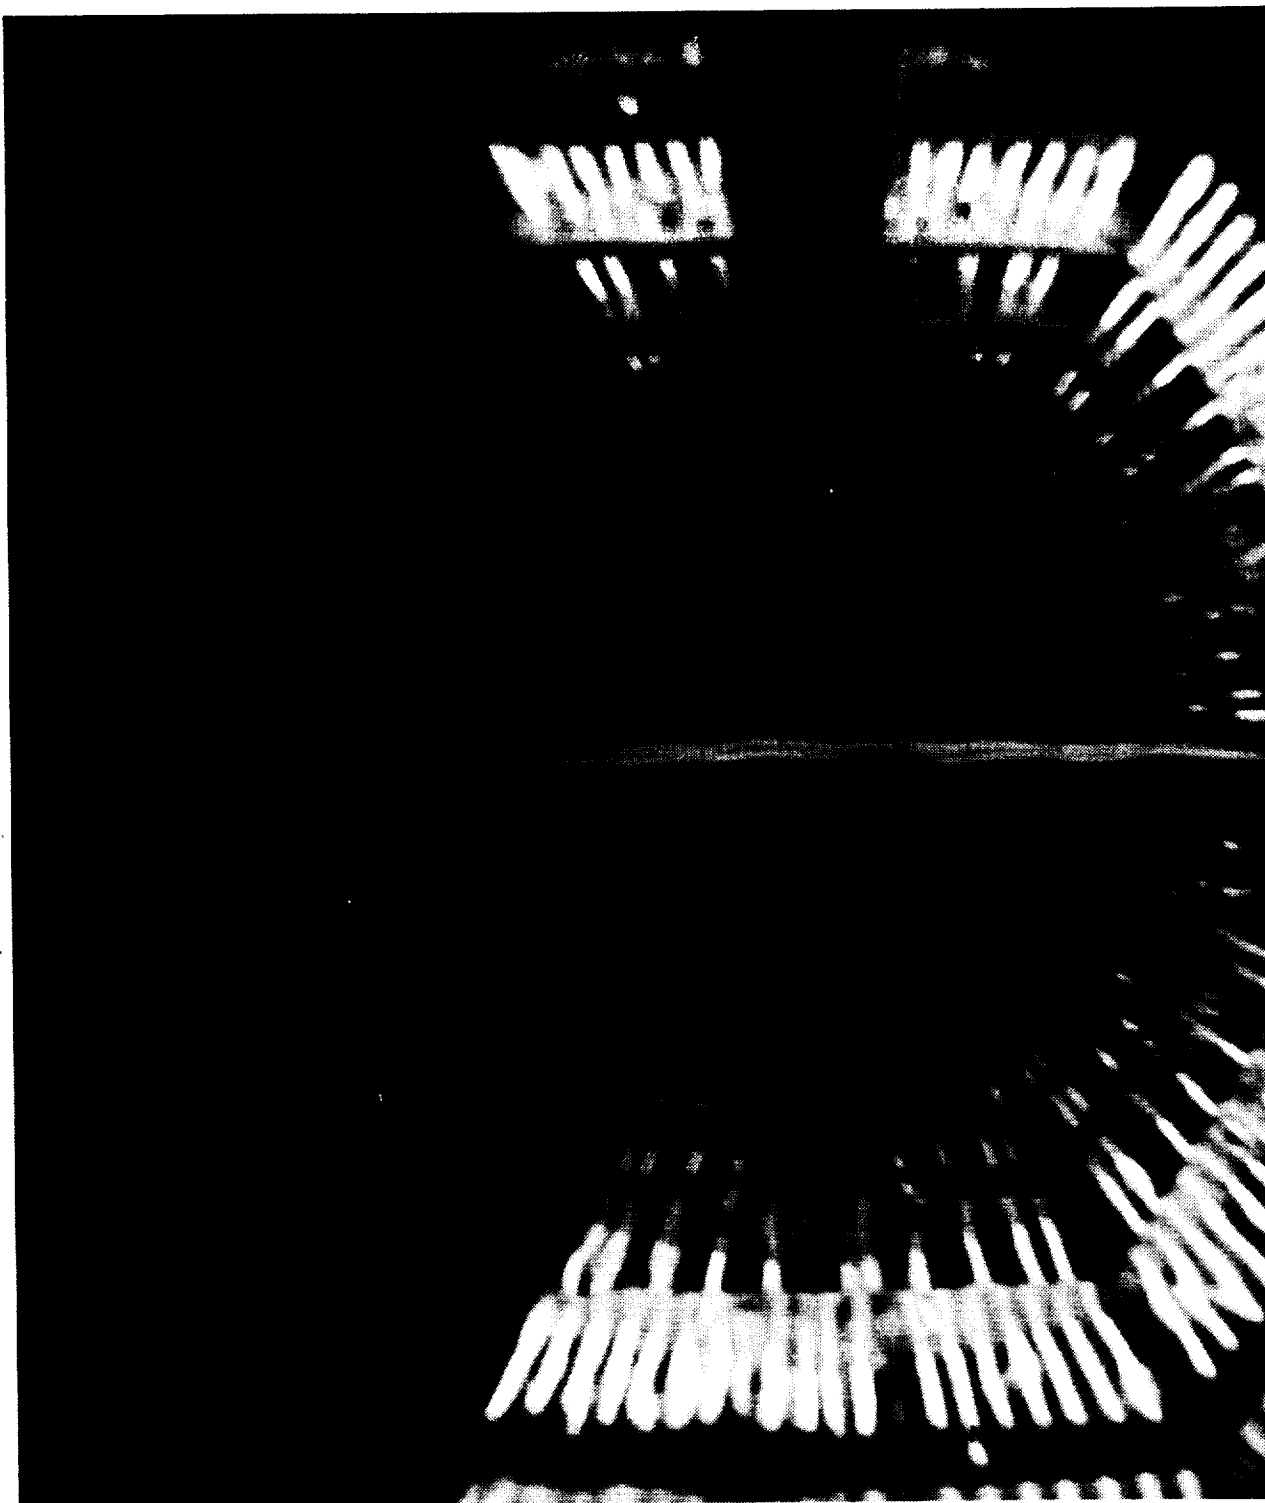
Figure 5-13: Borescope Image Showing the Loss of Quartz Lamp Heater Zones E and F at the End of Orbit #1.

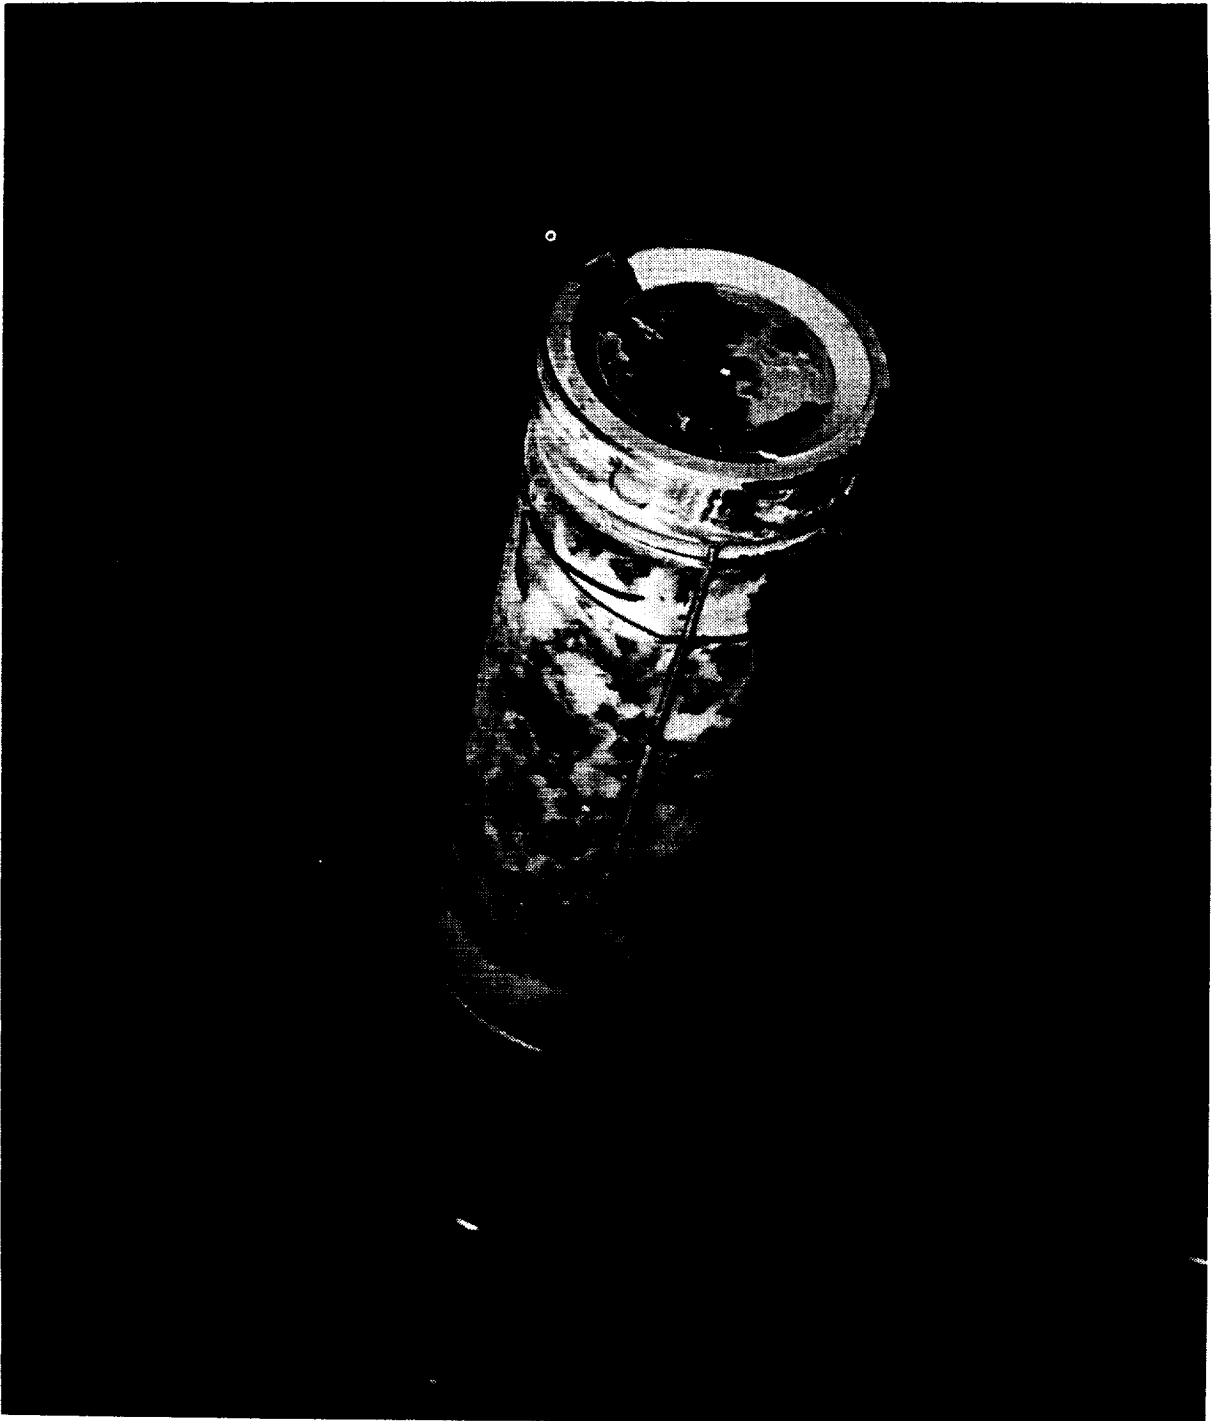
Figure 7-2: Contamination Collected on Borescope Lens During Testing.

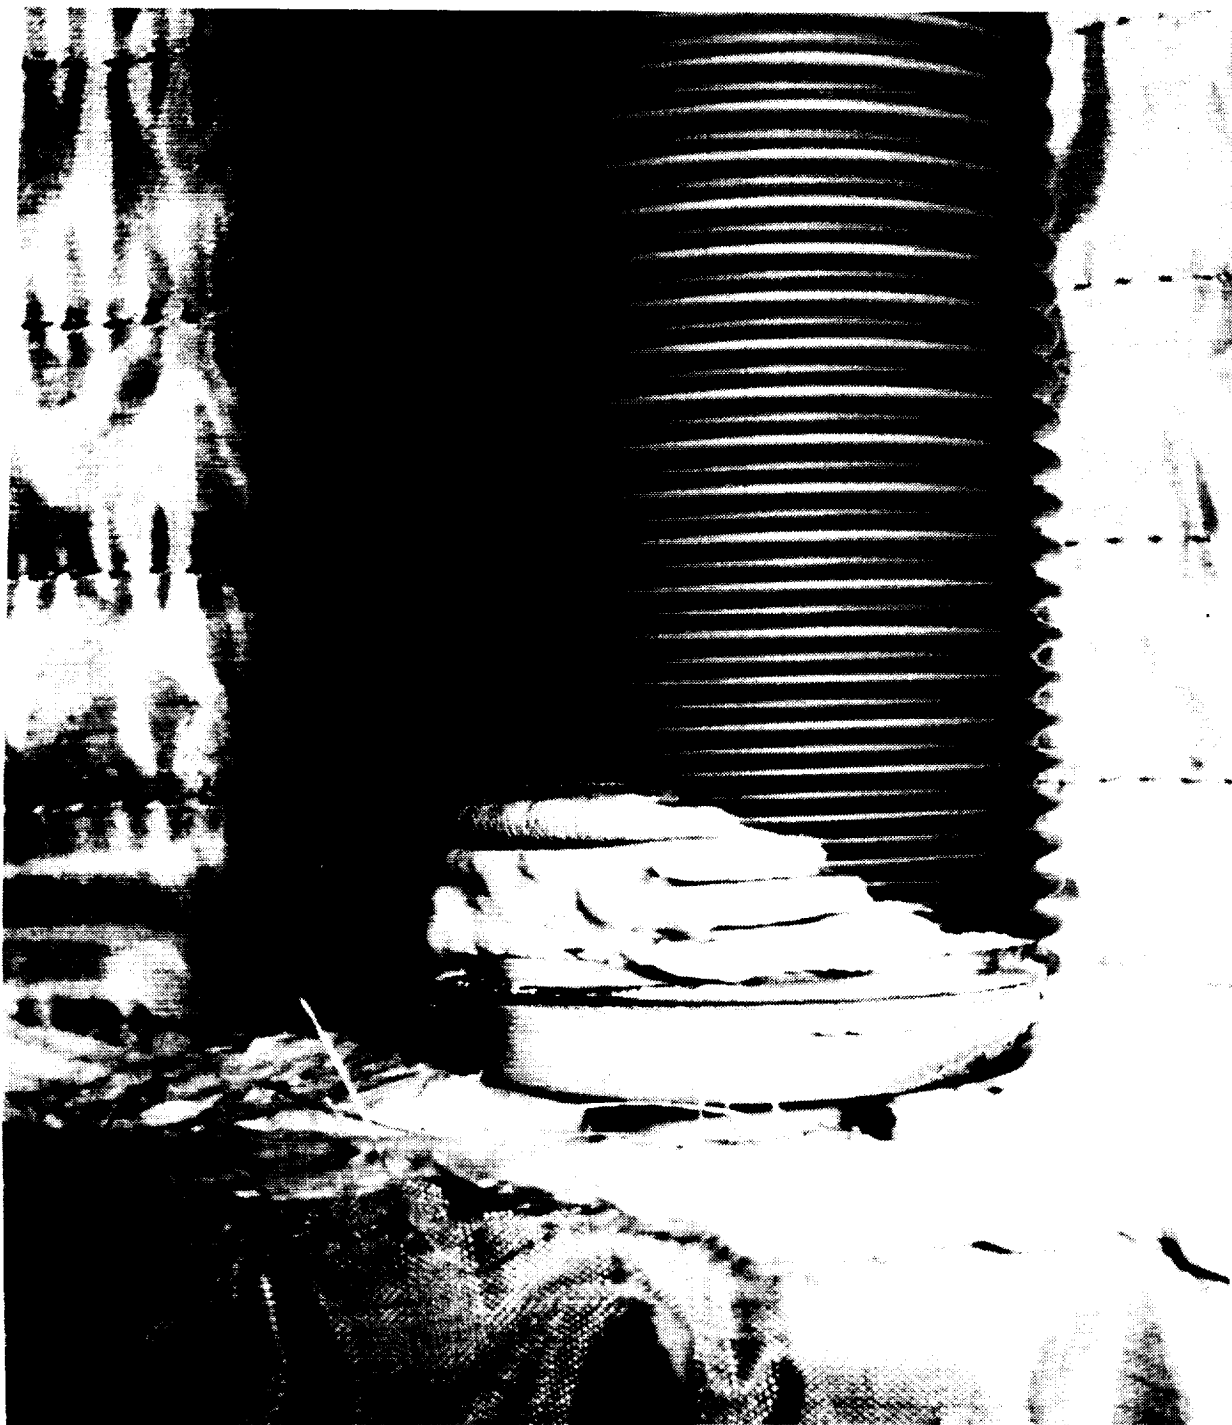
Figure 7-6: Crack At the Peak of the First Convolution at the Inlet End of Heat Storage Tube #3.

It is believed that most or all of these convolution ruptures occurred during the cold soak start up test mode CS.3 for the following reasons:

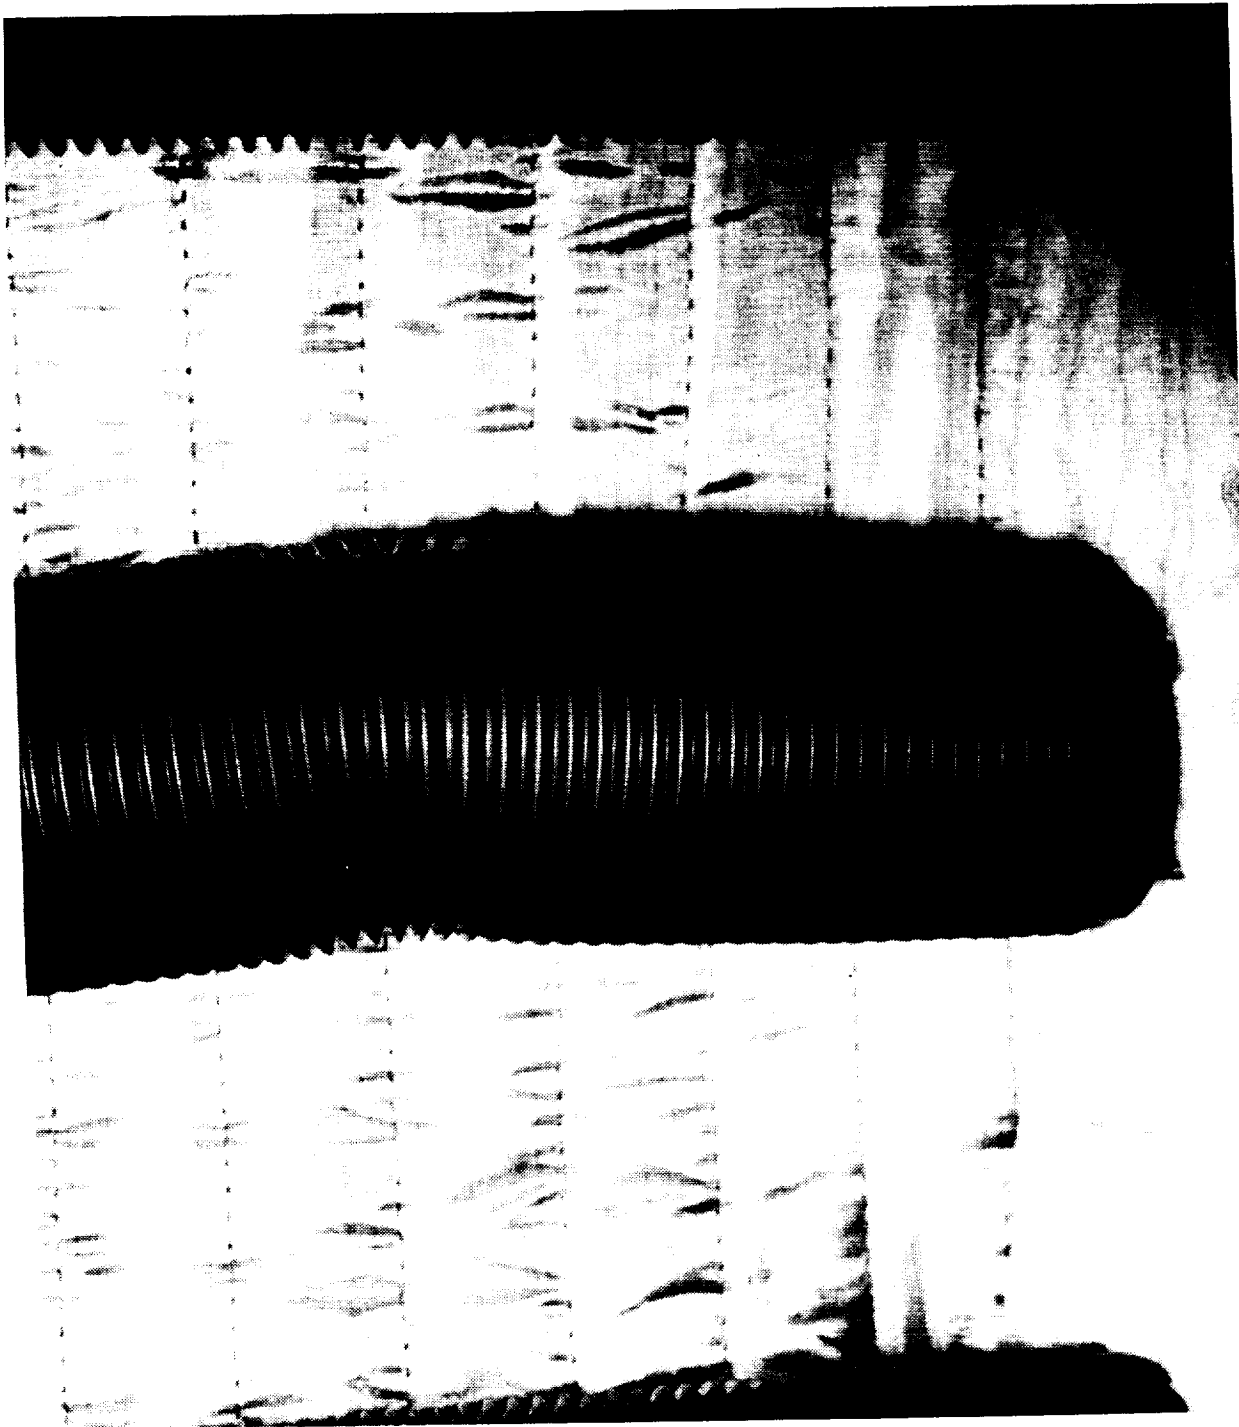
Figure 7-7: Buckled Felt Metal Kink Near the Inlet End of Heat Storage Tube #1.
